New York State Department of Transportation

Yellow Flag NB2228W022

BIN: 1065318
Feature Carried: 278I278IX2M23027
Feature Crossed: 6TH AVENUE
Orientation: 8 - NORTHWEST
Region: 11 - NEW YORK CITY
County: KINGS
Political Unit: City of NEW YORK
Approximate Year Built: 1962
Posted Load Matches Inventory : Yes
Bridge Load Posting (Tons) : Not Posted for Load
Primary Owner: New York State Department of Transportation
Primary Maintenance Responsibility: 12 - State - Subcontracted to another Party
Typical or Main Span Type: 3 - Steel, 02 - Stringer/Multi-Beam or Girder
This Bridge is not a Ramp
Number of Spans: 322

Location: Span 256 Girder G16 at Pier 256 over 3rd Avenue NB

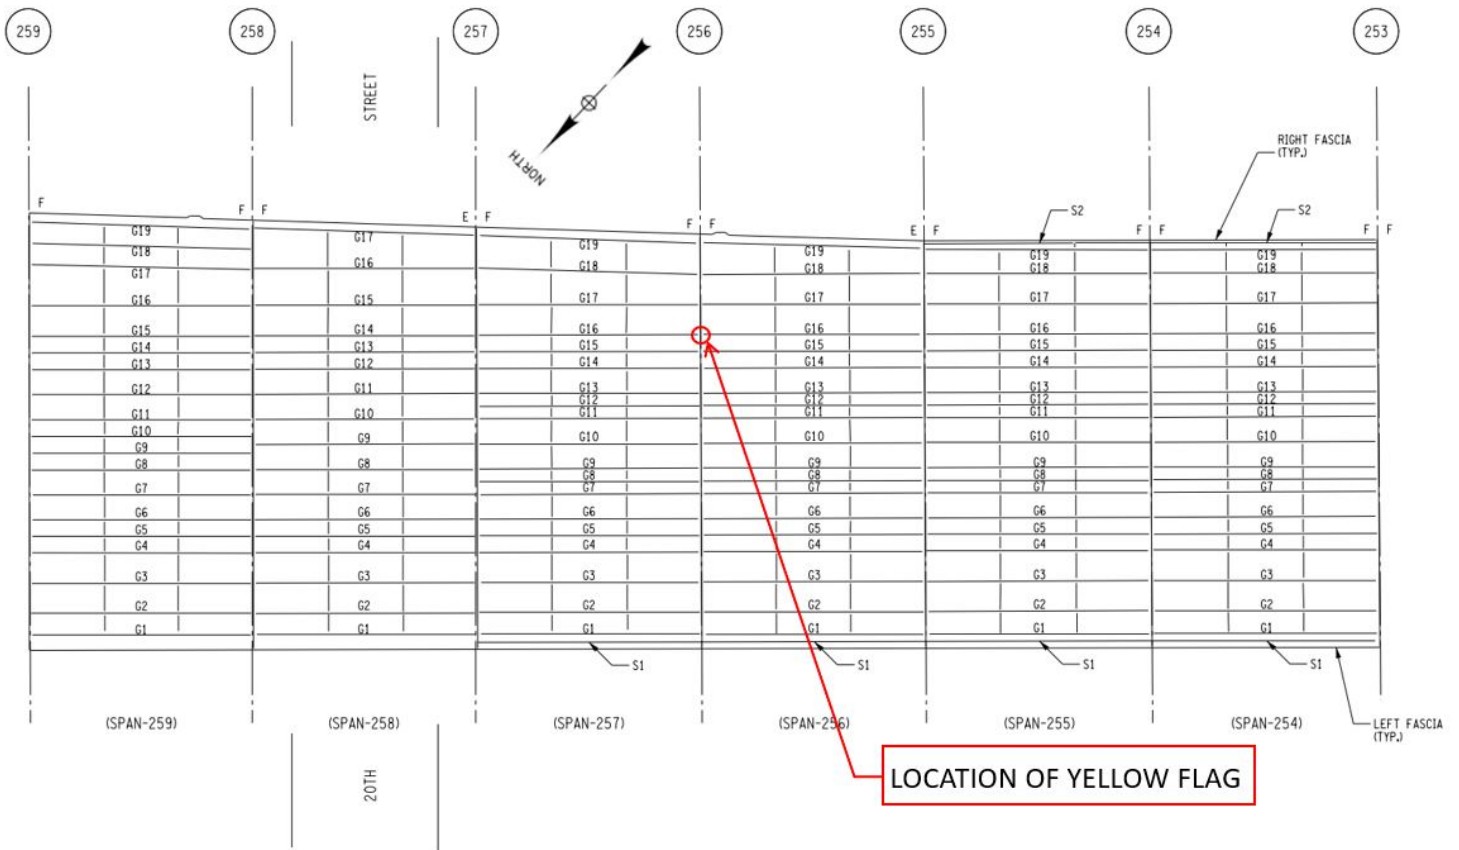
Flag PhotographsPhoto Number: **1**Photo Filename: **FRAMING PLAN.JPG**

**Attachment Description: BIN 1065318, Framing Plan, Spans 254 - 259**

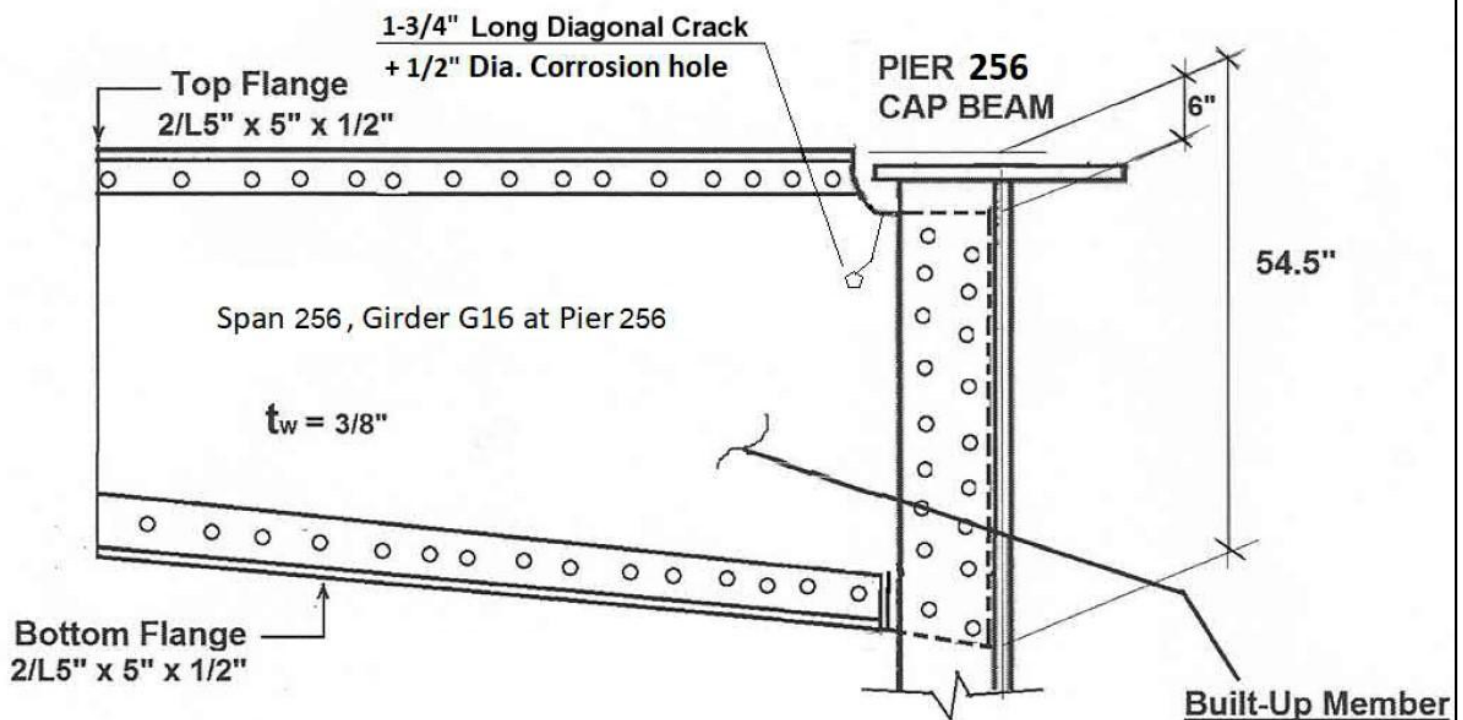
Photo Number: 2

The affected member Girder G16 is a load path redundant built-up steel girder consisting of varying web depth x 3/8" thick and two equal leg angles (L 5" x 5" x 1/2") for the top and bottom flanges (Photo 2). The spacing between Girder G15 and G16 is 3'-9.75" on center and 6'-11" on center from G17 (Photo 1).

**Built-Up Member**
Properties

Vary depth web: 54.5" b-to-b Ls @ Piers 255 and 256 and 33" @ midspan

Web thickness = 3/8"

Bottom and Top Flanges are two equal leg angles L 5" x 5" x 1/2"

Attachment Description: Sketch of G16 at Pier 246

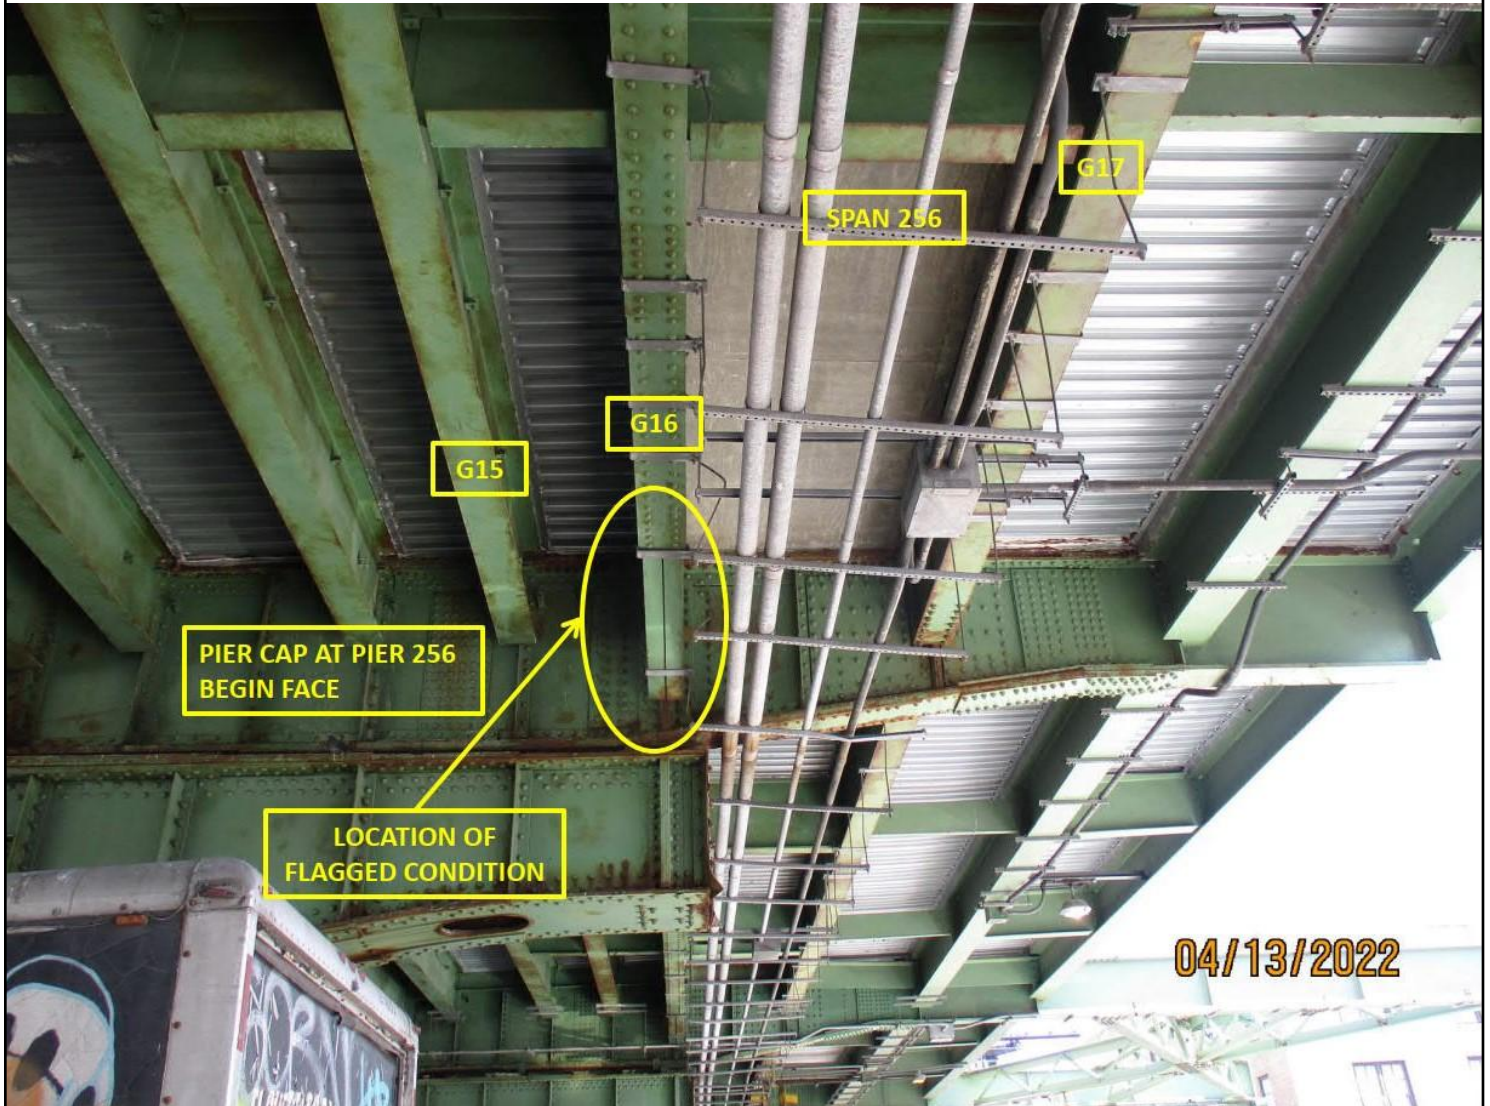
Photo Number: 3

Attachment Description: Span 256 G16 at Pier 256 – General framing plan of flagged location. Looking End.

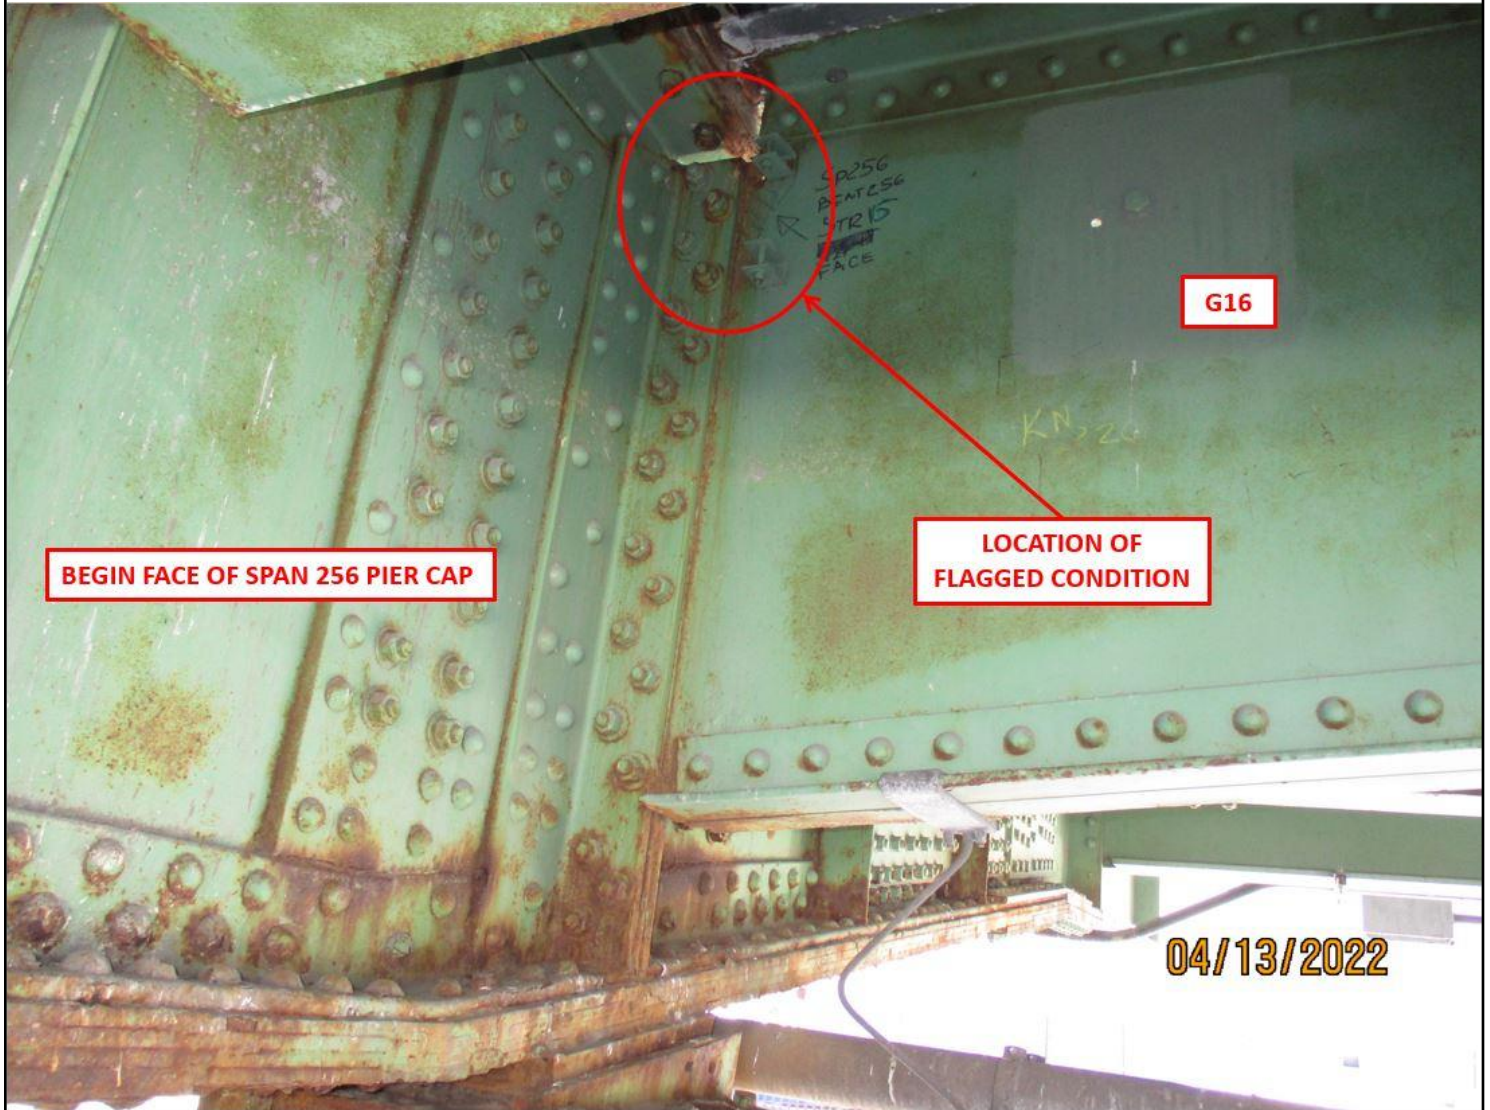
Photo Number: 4

Description: The web of the girder at the upper cope has a 1-3/4" long diagonal crack that extends into a 1/2" diameter corrosion hole. The surrounded web area of 11" H x 3" W has up to 3/16" deep section loss. (Photos 3, 4 and 5)

Attachment Description: Span 256 G16 at Pier 256 - General view of crack location at left upper cope. Looking End Right.

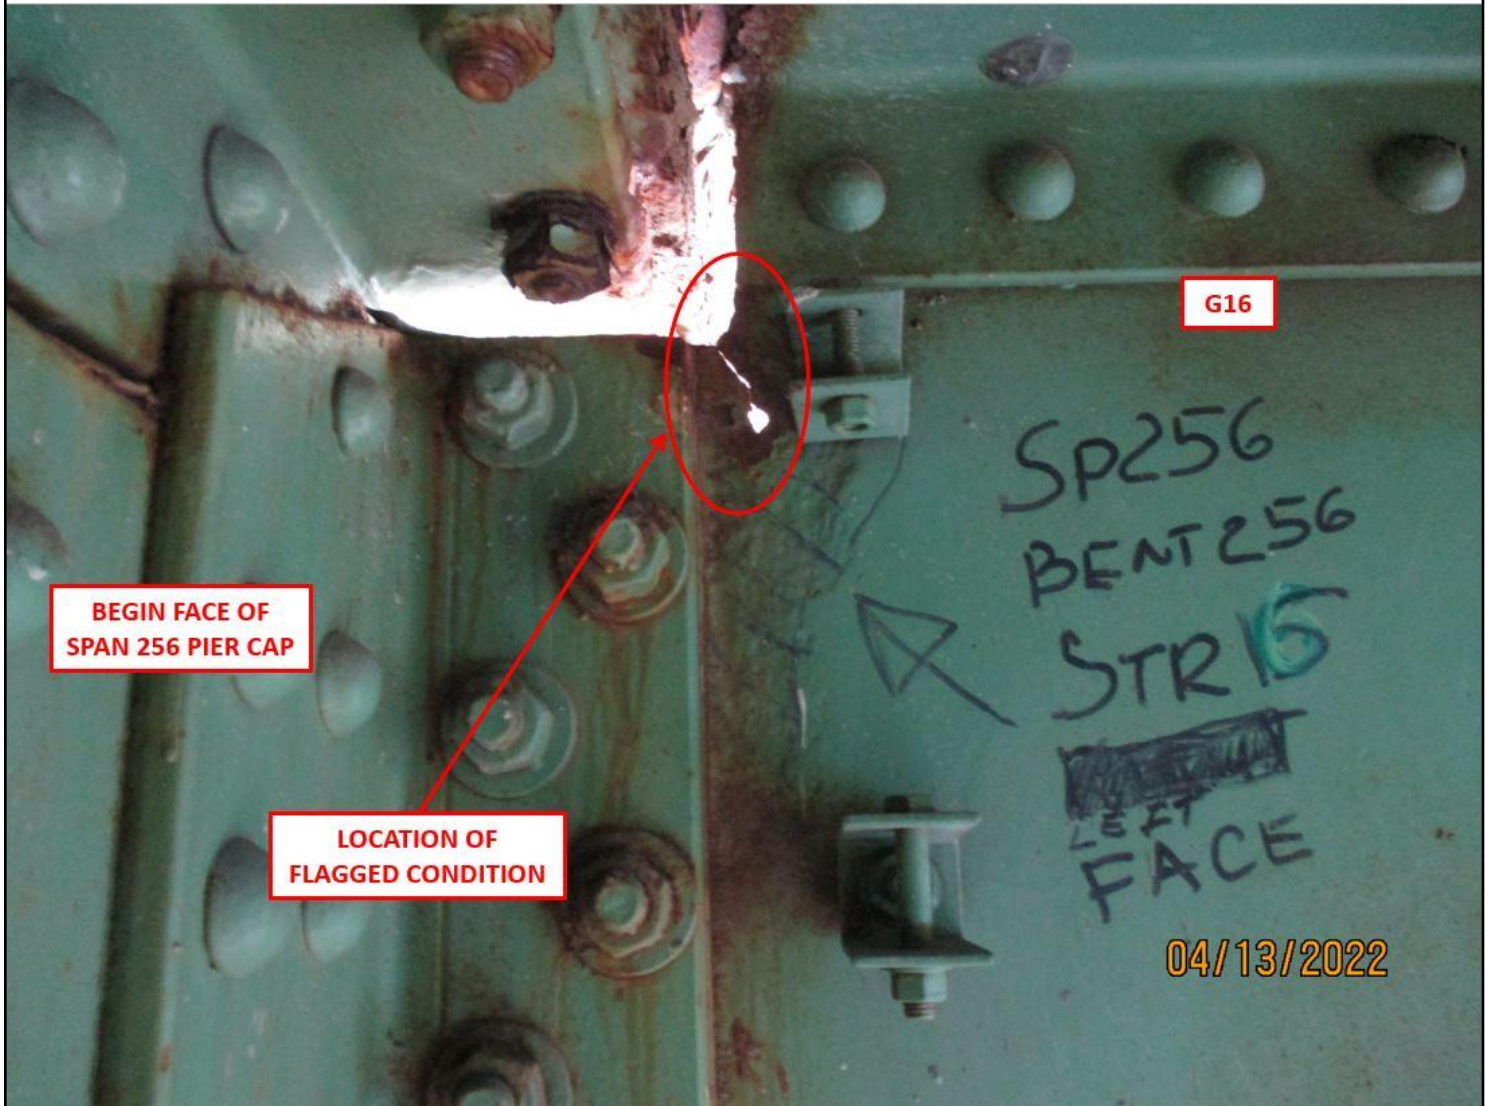
Photo Number: 5

Attachment Description: Span 256 G16 at Pier 256 – General view of flagged location showing the 1-3/4" long diagonal crack at upper cope and 1/2" diameter corrosion hole. Surrounding 11" H x 3" wide area with up to 3/16" DP section loss. Looking Right.

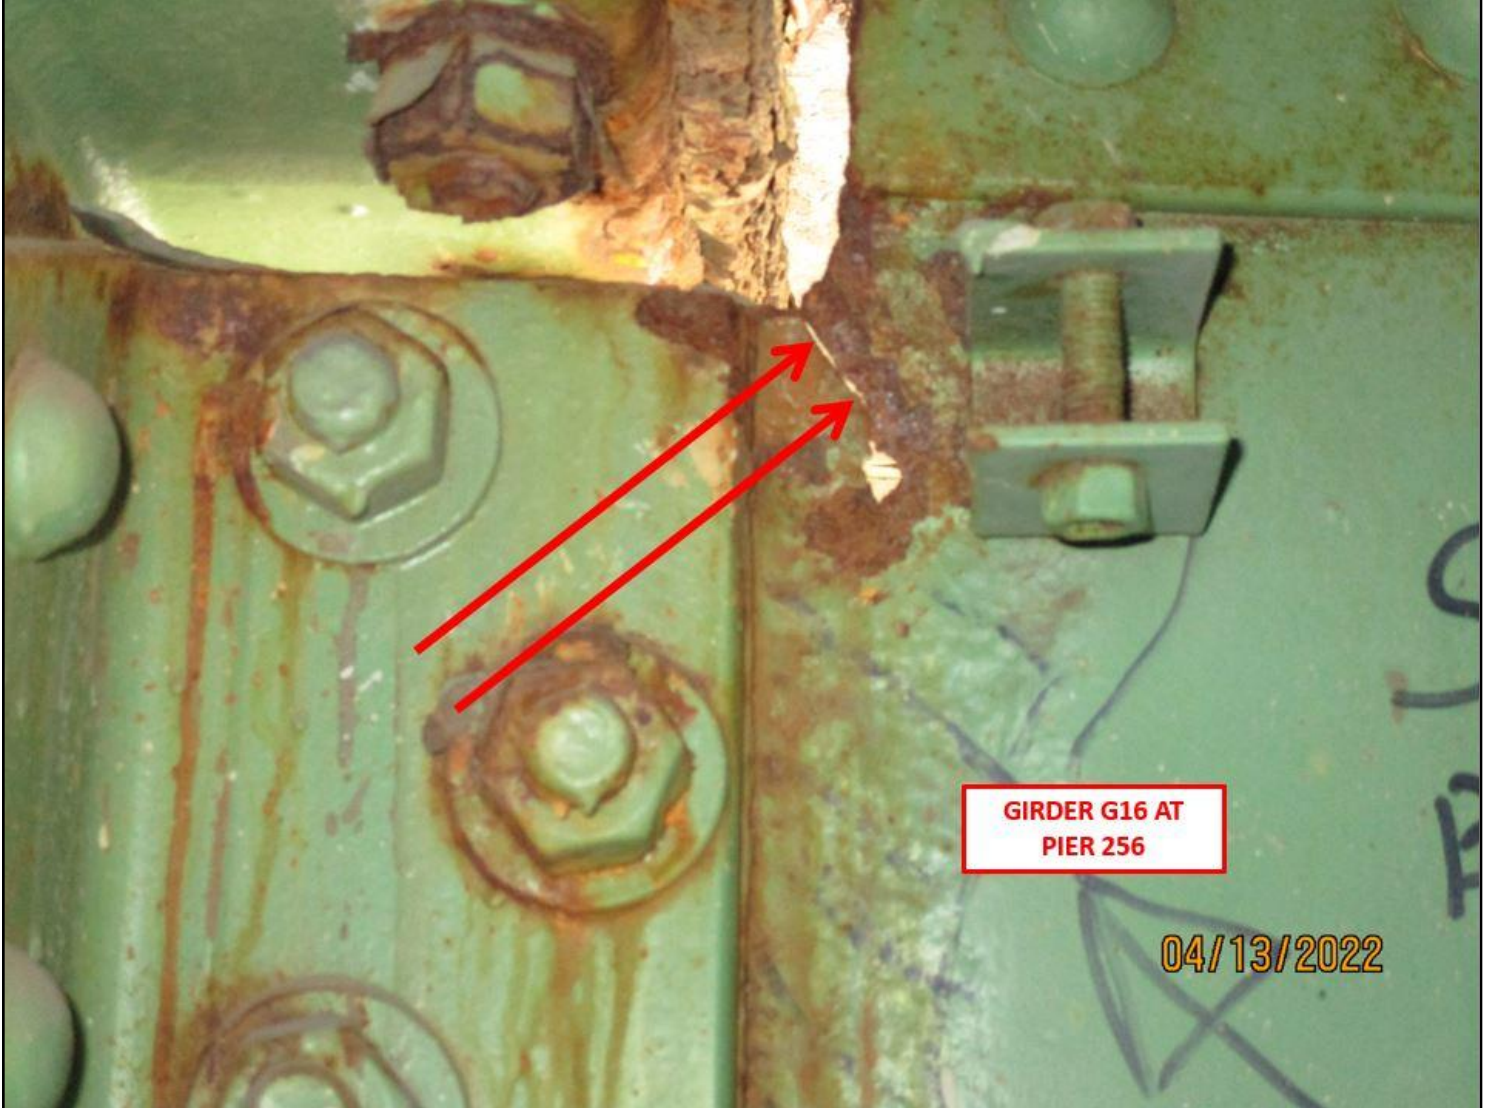
Photo Number: 6

Attachment Description: Span 256 G16 at Pier 256 – Close up view of the 1-3/4" long diagonal crack at upper cope and 1/2" diameter corrosion hole. Looking Right.

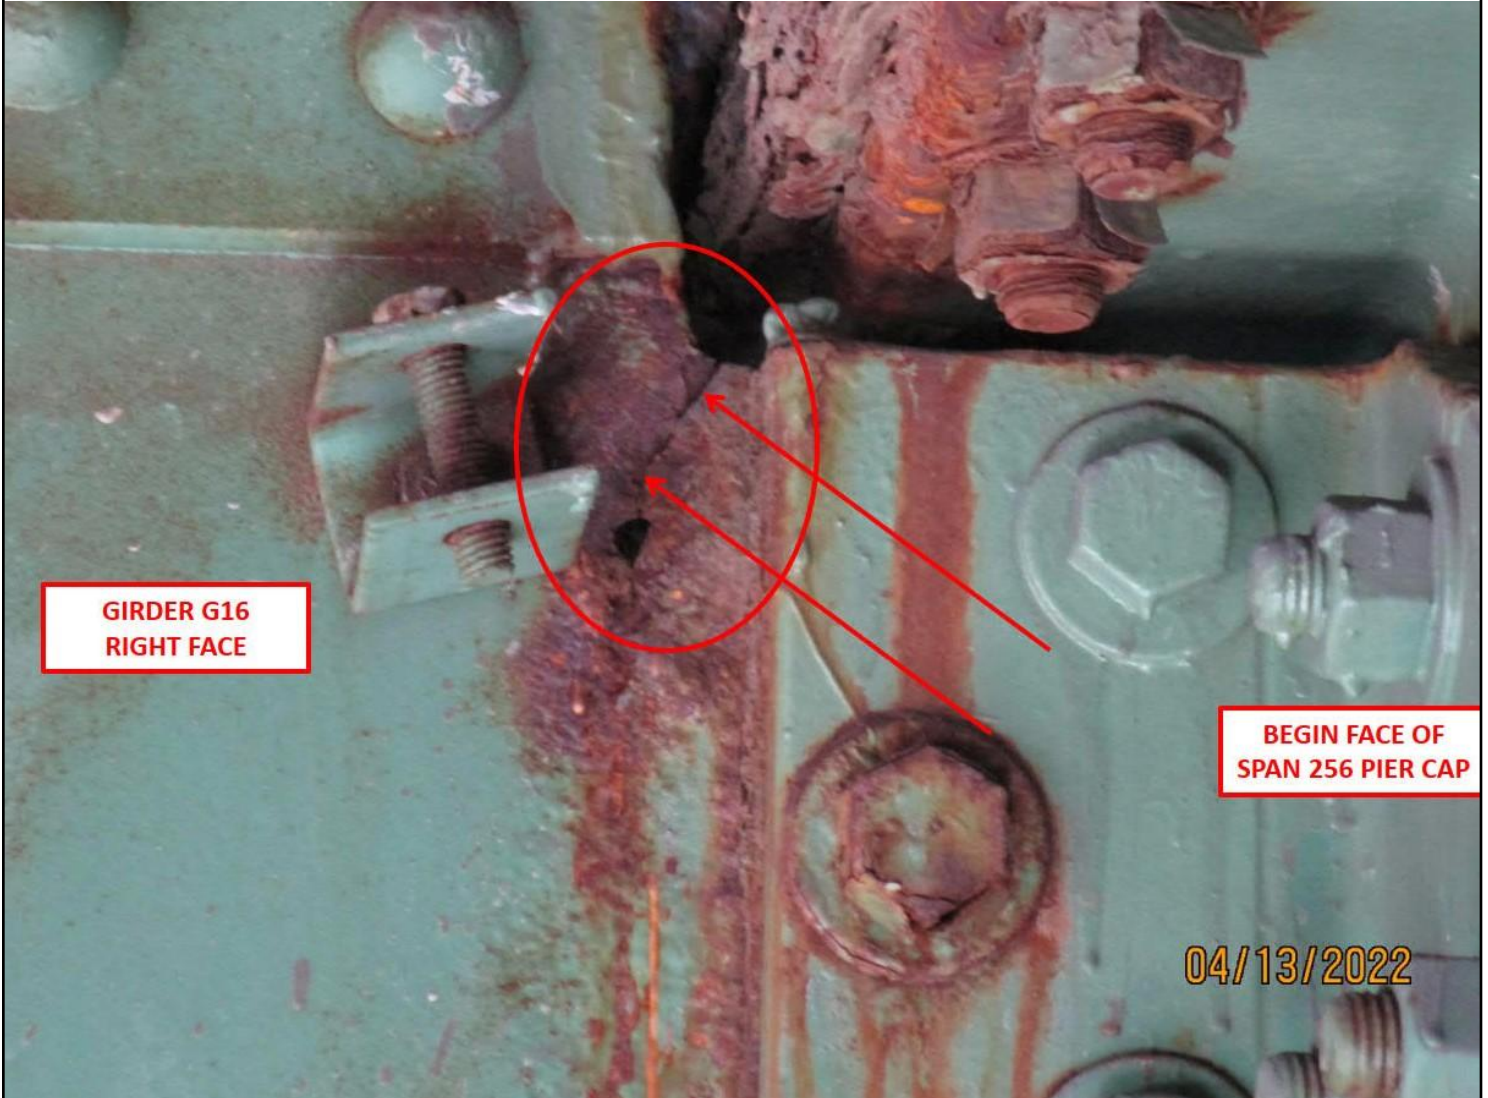
Photo Number: 7

Attachment Description: Span 256 G16 at Pier 256 – Close up view of the 1-3/4" long diagonal crack at upper cope and 1/2" diameter corrosion hole. Looking Left.
